INSTRUCTION: TN02623  
Rev. 01-10-2011 DNE  
APPROVAL: \_\_\_\_\_

## TE02623 AND TAS75, CONTACT HEAT ELEMENT INSTALLATION INSTRUCTIONS

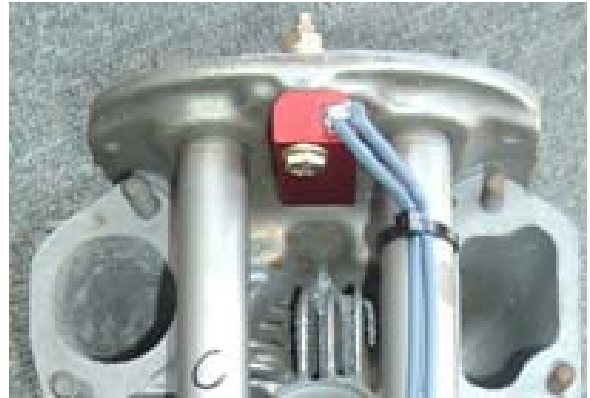
TE02623 (TAS75) on Continental cylinder head.  
Figure 1

The TE02623 and TAS75, contact (block) heat elements are sub components of Tanis preheat systems. These elements are intended for installation on Continental straight/parallel valve cylinder heads. The lower rocker cover bolt is removed, and the element is then secured in place between the pushrod tubes using through bolt, washers, and hot-stop nut, in place of the factory bolt.

1. Remove lower rocker cover bolt.
2. Install the element vertically between the pushrod tubes with beveled edges toward the head as shown in Figure 1.
  - a. Note direction of bolt, and securing of leads to push rod tube.
  - b. When handling the element do not flex the leads unnecessarily, damage may result to the wiring
3. Install supplied flat washer and bolt from the backside of the element exiting through the cylinder flange and rocker cover. Install washer and hot stop nut and torque.  
Note: Removal of sparkplug ignition lead may be required in some instances.
4. Torque to the replacement configuration to OEM specifications for location of installation.
5. Secure element leads. Suggested location is on the intake pushrod tube, Figure 1.
6. If sparkplug ignition lead was removed, replace and re-torque.
